POOR COYOTE'S CABIN  
NEZ PERCE NATIONAL HISTORICAL PARK  
SPALDING  
NEZ PERCE COUNTY  
IDAHO

HABS No. ID-75

HISTORIC AMERICAN BUILDINGS SURVEY  
POOR COYOTE'S CABIN

SKETCH PLAN  
POOR COYOTE'S CABIN  
NEZ PERCE NATIONAL HISTORICAL PARK  
HABS NO. ID-75

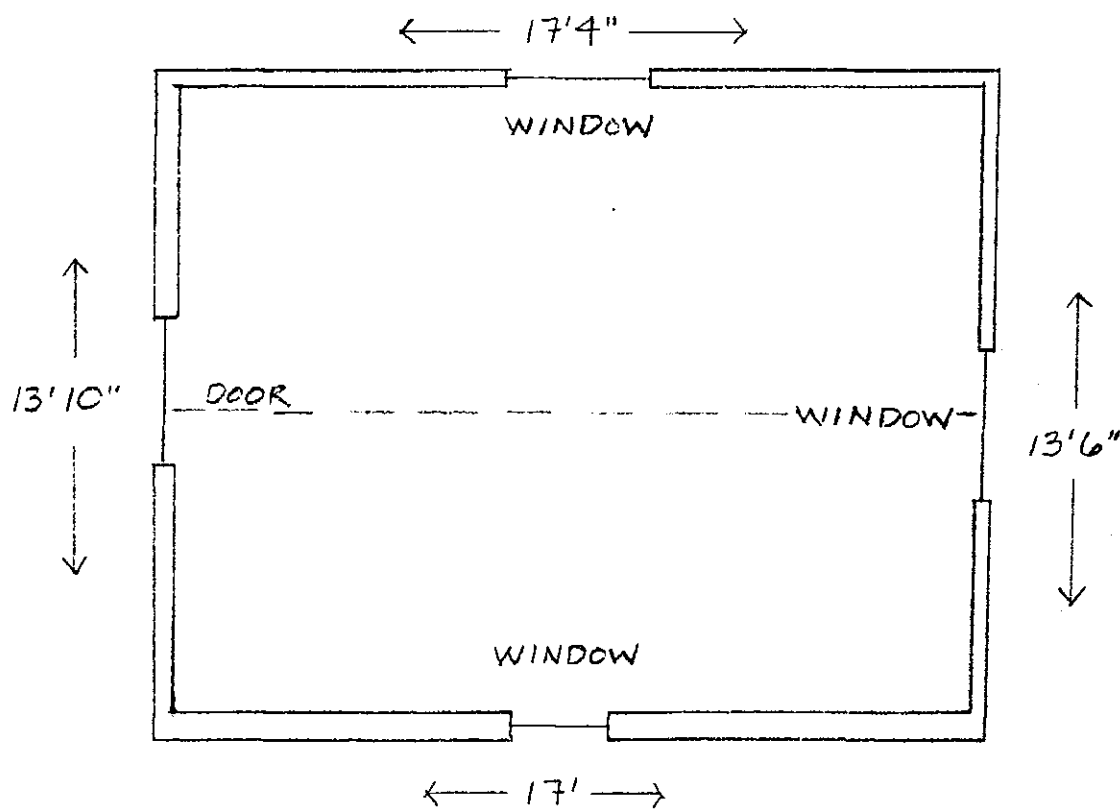
Poor Coyote's Cabin is a rectangular, one-story, gable-roofed log cabin approximately 13' 10" x 17' 4" in dimension. The structure does not sit on a foundation: a set of log skids with braces carries the building. The logs of the cabin are a combination of heavily-hewn, almost squared logs and slightly hewn ones. Those closest to the ground have been de-barked. On close visual inspection, faint numerals can be seen painted on the logs, lower value at the bottom of the structure, proceeding higher in sequence up through the gable. Numbers are missing on one or two sills logs and the spandrels. The logs without numbers show no sign of hewing. The chinking between the logs is a soft lime mortar with insets of highly colored stone up to 2" in diameter. This distinct chinking was done by the Evans.

The north, south and east walls each have one centered rectangular window opening, all with plain wood board trim. The window openings and casings appear to be original. The sash were 4-pane factory-built casements, 2' 0" wide by 2' 9" high, although these all appeared to be later additions to the building. Only one casement frame (no glass) remains on the north wall. The door opening is centered on the west elevation and has only one trim piece intact. The door is now missing, but based on earlier photographs from the Evans' era it was a 4-panel, 2' 6" by 5' 11", wood door with the top glazed (an upper transom?). The original door, as shown in a ca. 1900 photograph of the cabin when it was located at Coyote Gulch, appeared to be of board and batten construction.
